J Occup Environ Hyg. 2013 ; 10(3): D34–D39. doi:10.1080/15459624.2012.750555.

Evaluation of Air Sampling Methods for Abrasive Blasting

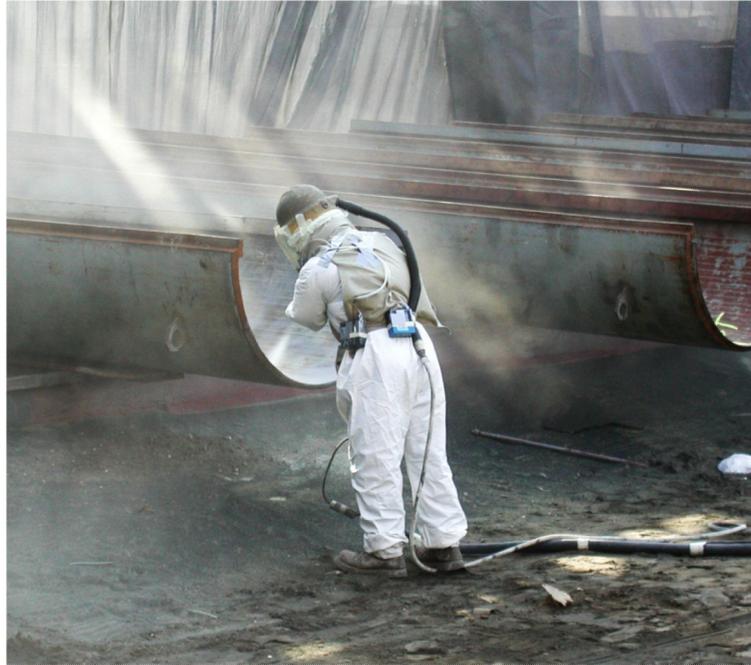
Figure 1. Employee performing abrasive blasting of the surface of a shaft cover. Employee is wearing gloves, boots, coveralls, a Type CE airline respirator, and two sampling pumps.

Employees performing abrasive blasting were provided with showers and separate lockers for street and work clothes. They were required by the shipyard to participate in a medical monitoring program that included physical examinations. An abrasive blaster at this shipyard wore gloves, boots, coveralls, and a Type CE airline respirator (Figure 1).

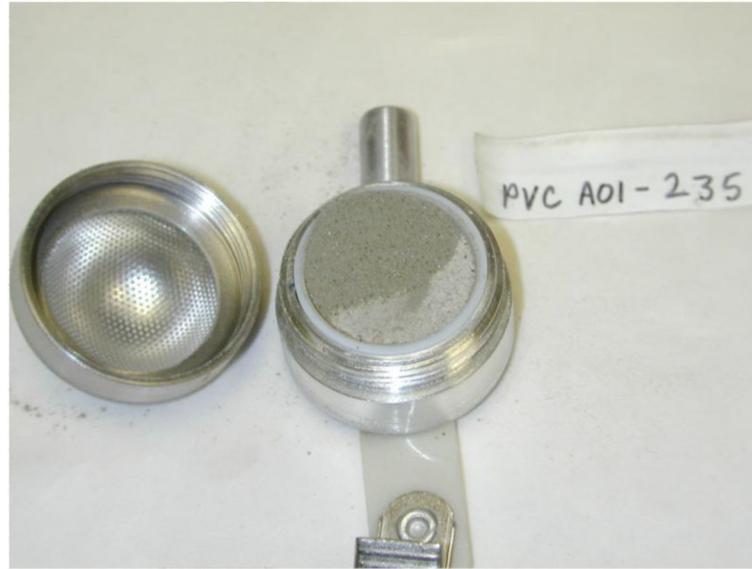
Figure 2. Loose particulate inside a shielded BAS active sample. The external shield that would go over the protective screen is not shown.

As shown in Figure 2, the shielded BASs overloaded despite the protective shield. The shielded BAS shown in Figure 2 was connected to a pump that faulted 10 minutes into the 61-minute sampling period. Figure 3 shows a 37-mm cassette sample whose pump operated for the entire 61-minute sampling period. Both samples in Figure 2 and 3 were grossly overloaded, well beyond the recommended maximum sample weight of 2 mg per sample.

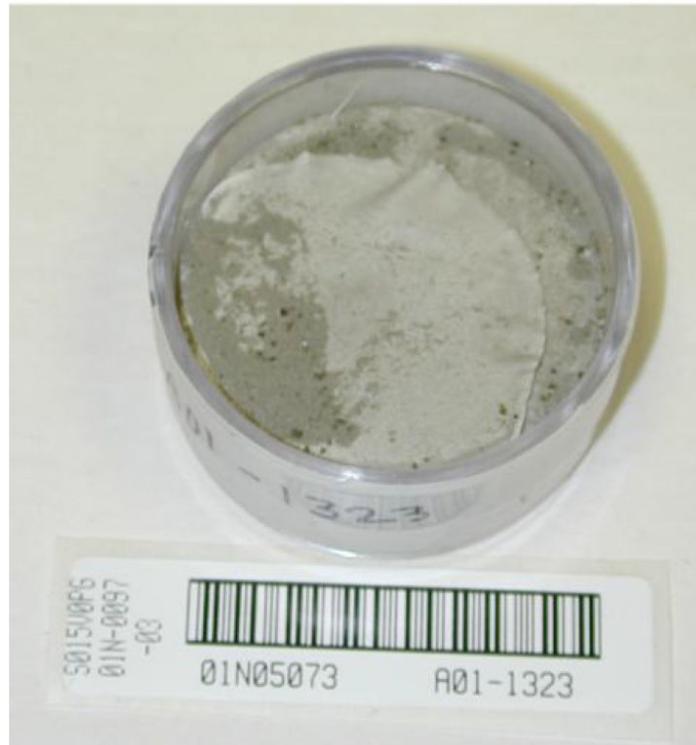
Figure 3.
Loose particulate and a damaged filter from a 37-mm filter cassette active sample.
